Tech Tip

2006 Ford Ranger
3.0 Liter V6

This Ford Ranger's engine was replaced due to a cylinder with low compression. After the replacement engine was installed the vehicle exhibited a "Tip In Hesitation". The MIL (Check Engine Light) was not illuminated and there were no codes stored in the ECM.

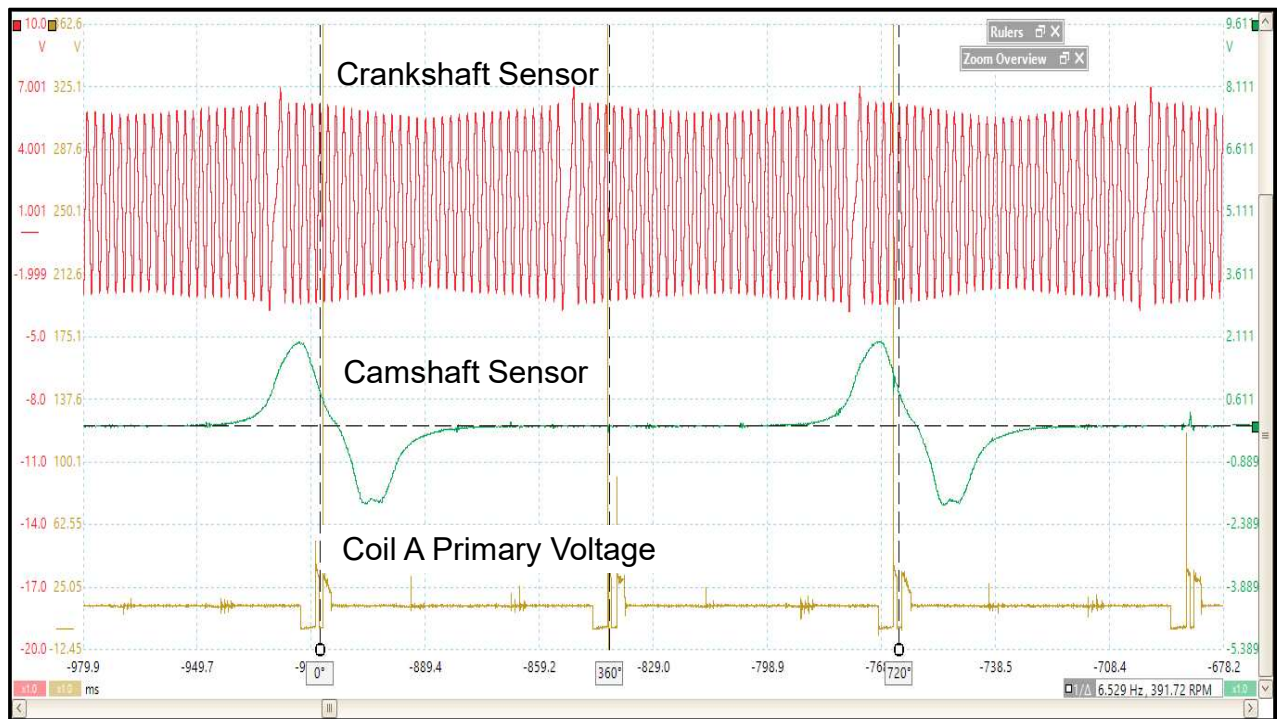
This particular engine uses a 36 – 1 Tooth Crankshaft Reluctor (35 pulses, each representing 10 degrees of crankshaft rotation). The two wire permanent magnet type sensor creates an A/C Sine Wave and missing tooth on Ford’s V6 engines represents 60 degrees before Top Dead Center Compression Cylinder #1 and Cylinder #5 (meaning in two revolutions of the crankshaft the anomaly will show itself twice).

The Camshaft Sensor’s pulse is supposed to happen 26 degrees After Top Dead Center Cylinder #1. So the question: is the Camshaft Sensor / Crankshaft Sensor timed correctly.

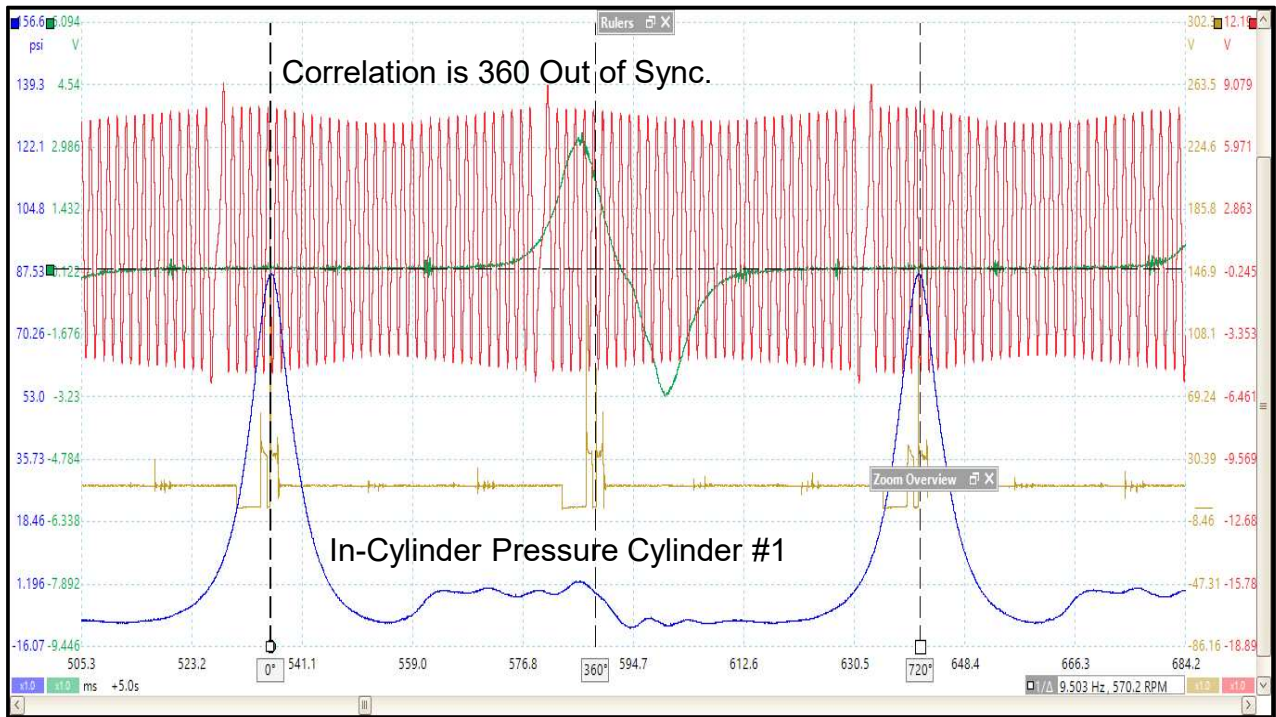
Using the Ignition Coil’s Primary Voltage to “Sync” the Camshaft Sensor signal doesn’t work.

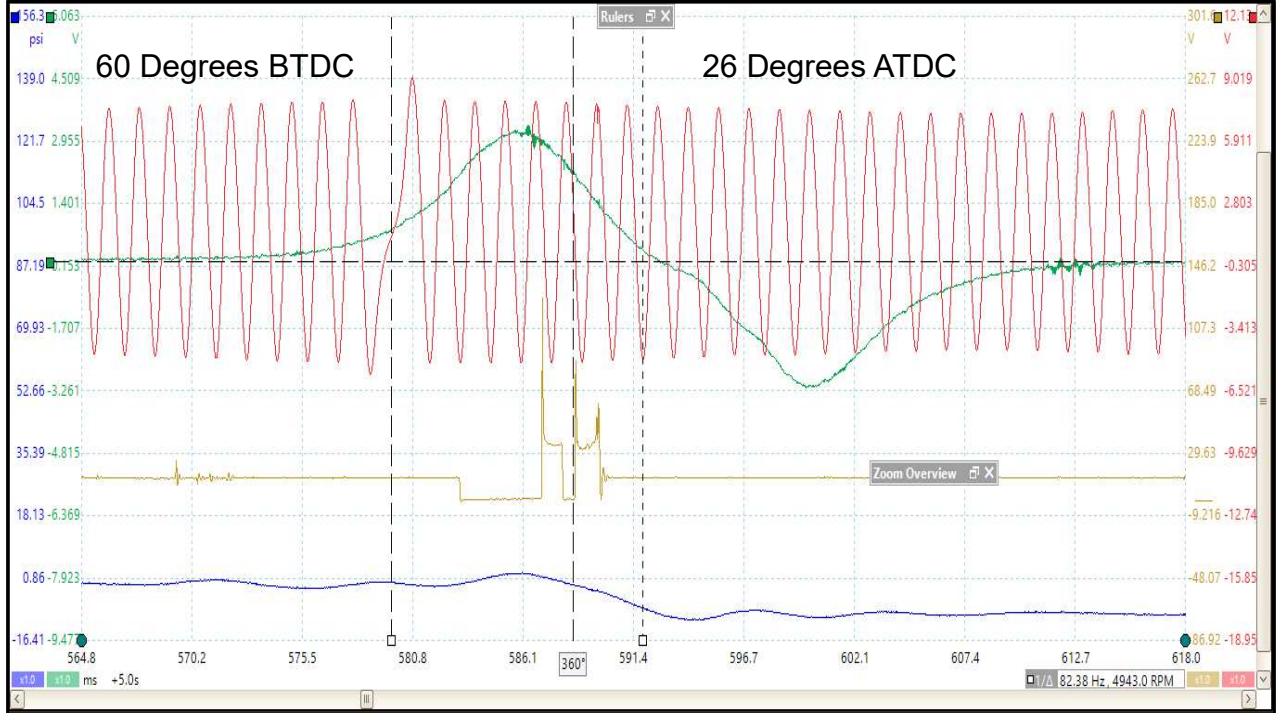
An In-Cylinder Pressure Transducer was added to Cylinder #1 (blue trace). The above waveform shows the Camshaft Sensor signal is 360 degrees “Out of Time”. When the technician installed the synchronizer, Cylinder #1 was at Top Dead Center Exhaust (meaning Cylinder #5 was at Top Dead Center Compression).

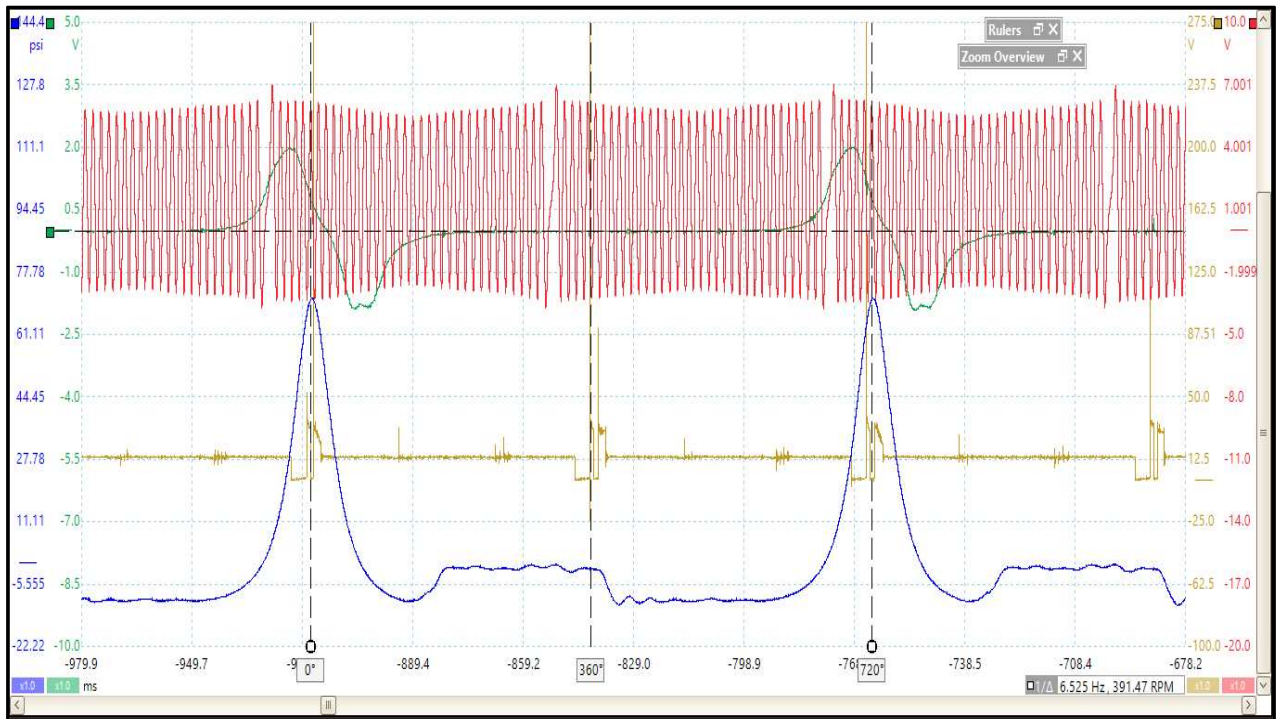
Zooming into the waveform the Crankshaft / Camshaft Correlation can be measured. Because with Ford we know the missing tooth represents 60 Degrees Before Top Dead Center we can count over 8 1/2 Teeth to check the correlation.

Although the sensor was installed incorrectly (because it's installed 360 Degrees out of Phase) the alignment is correct (8 1/2 teeth over from the anomaly) which is why there was no MIL Illuminated.
