## Tech Tip

2013 Honda Civic  
1.8 Liter 4 Cylinder SOHC  
(Single Overhead Camshaft)

The vehicle was brought in due to a “Rough Running” condition and an Illuminated Malfunction Indicator Light (MIL). The 1.8 Liter engine is timing chain driven and no internal engine work had been performed prior to the start of this issue.

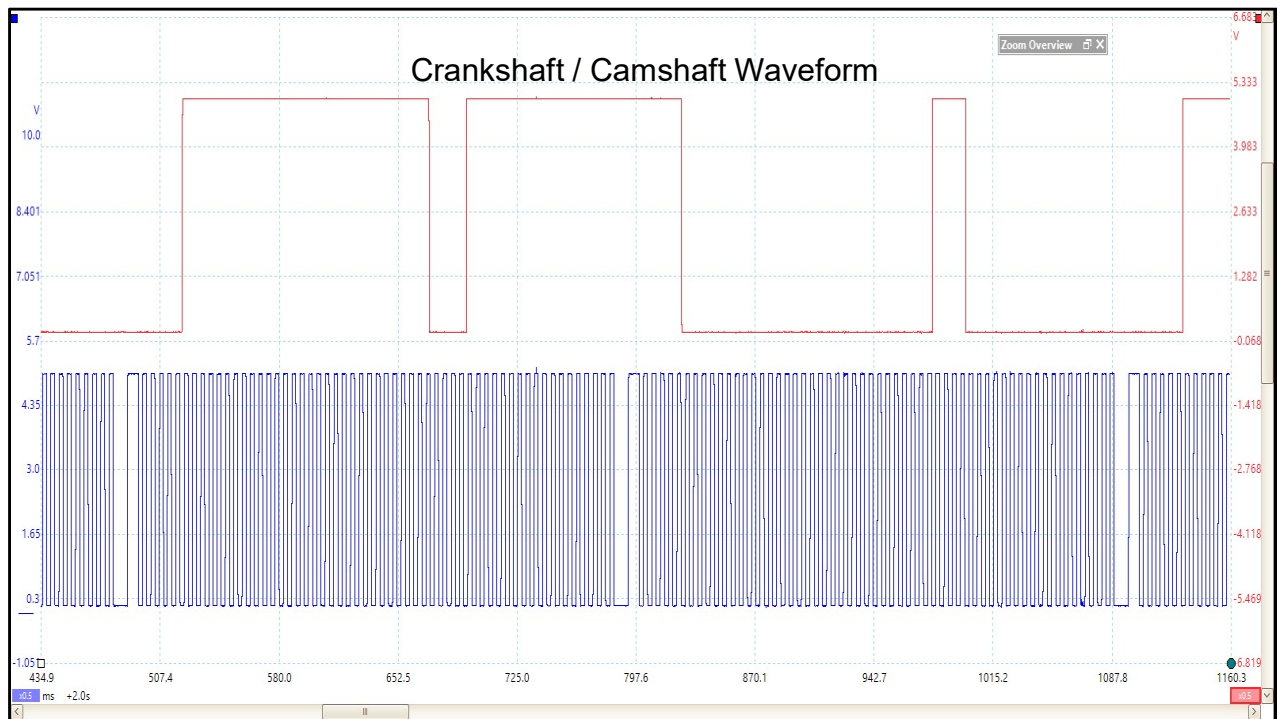
The above waveform is the Crankshaft Sensor (in blue, lower trace) and the Camshaft Sensor (in red, upper trace). The Crankshaft / Camshaft Correlation is un-known, because a “Known Good Waveform” could not be located using all available resources.

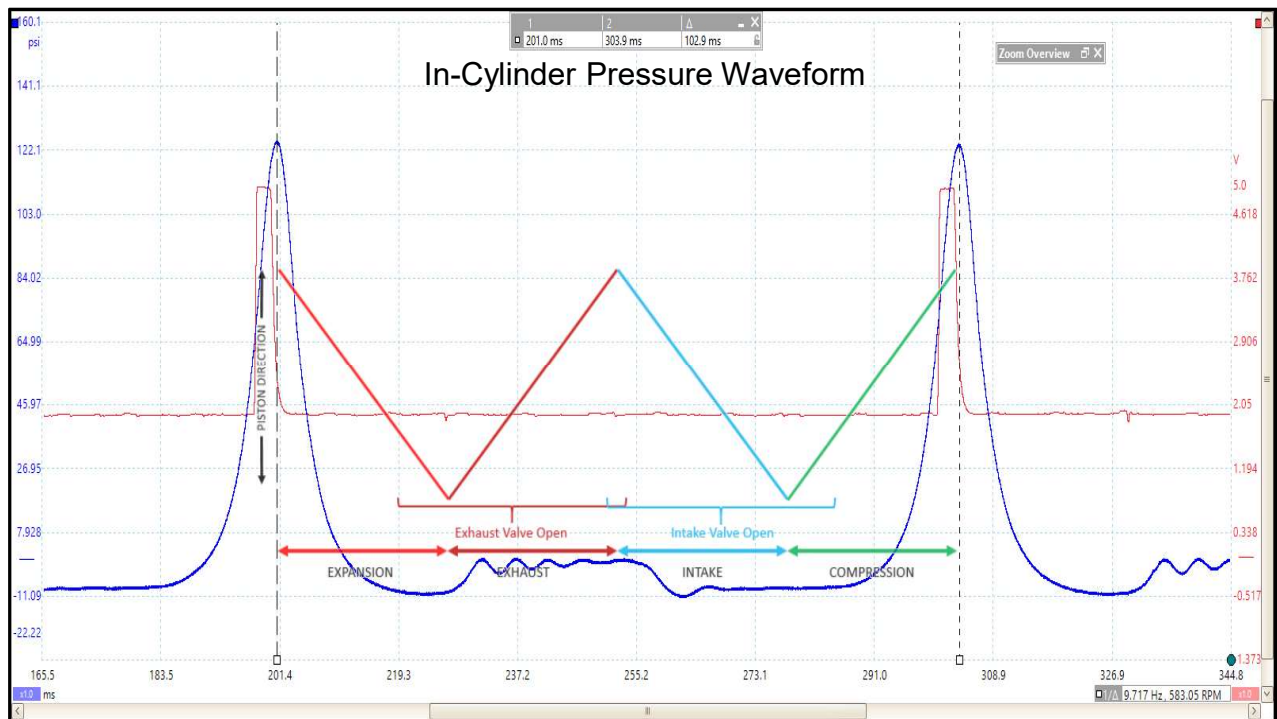
Due to the overwhelming amount of work previously performed on the vehicle and the uselessness of the Crankshaft / Camshaft Correlation Waveform it was determined In-Cylinder Pressure Transducer Testing was going to be our best option for pin-pointing the “Route Cause” of the “Rough Running”.

The overlay added to the above waveform helps explain the four different strokes of the piston, in relationship to the In-Cylinder Trace (in blue). The red trace is the Ignition Timing signal from the vehicle’s Electronic Control Module (ECM) for the cylinder being tested.

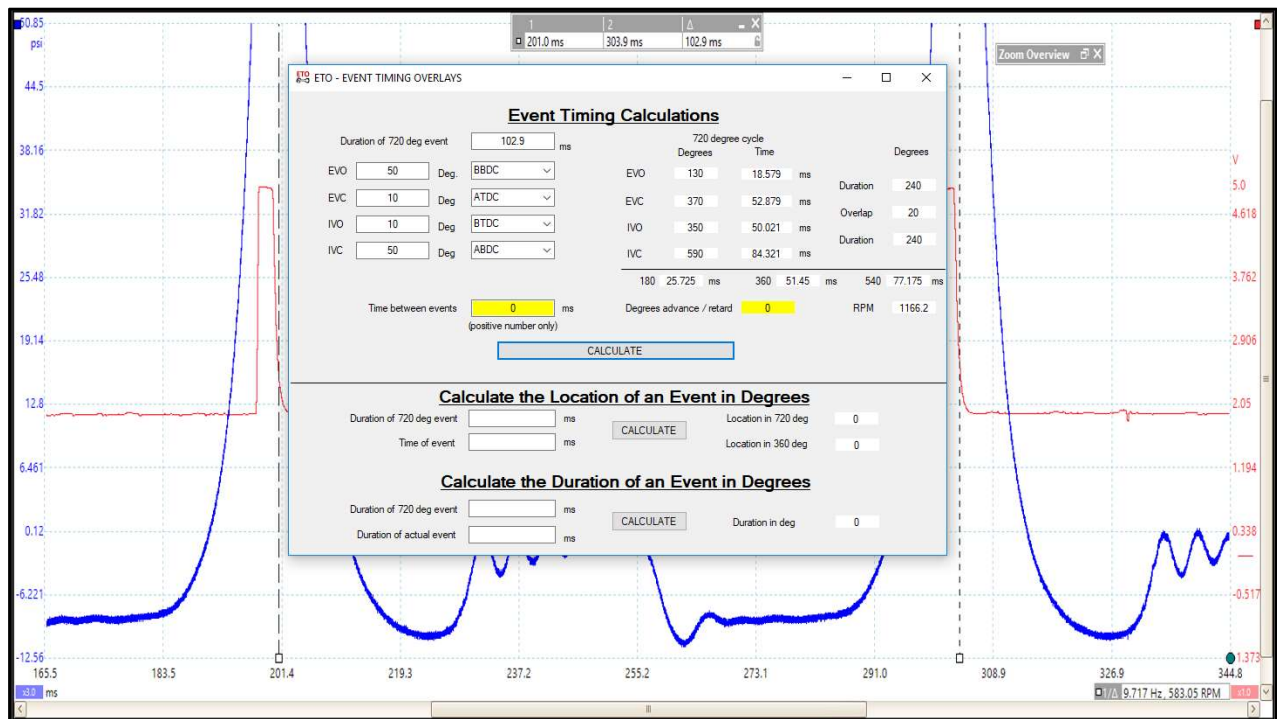
The two peaks of the trace represent Top Dead Center of the Compression Stroke. Between the two peaks is 720 degrees of Crankshaft Rotation. Using the cursors of the lab scope "Time" can be measured between the two peaks. This amount of "Time" will help determine the intended Exhaust Valve Opening & Intake Valve Closing points so an analysis can be made regarding Crankshaft / Camshaft Correlation.

In this example 720 degrees of crankshaft rotation happened in 102.9 milliseconds of time. Inputting this number into the calculator will give the "Intended Time Indicators" for when the Exhaust Valve Opening & Intake Valve Closing events should occur

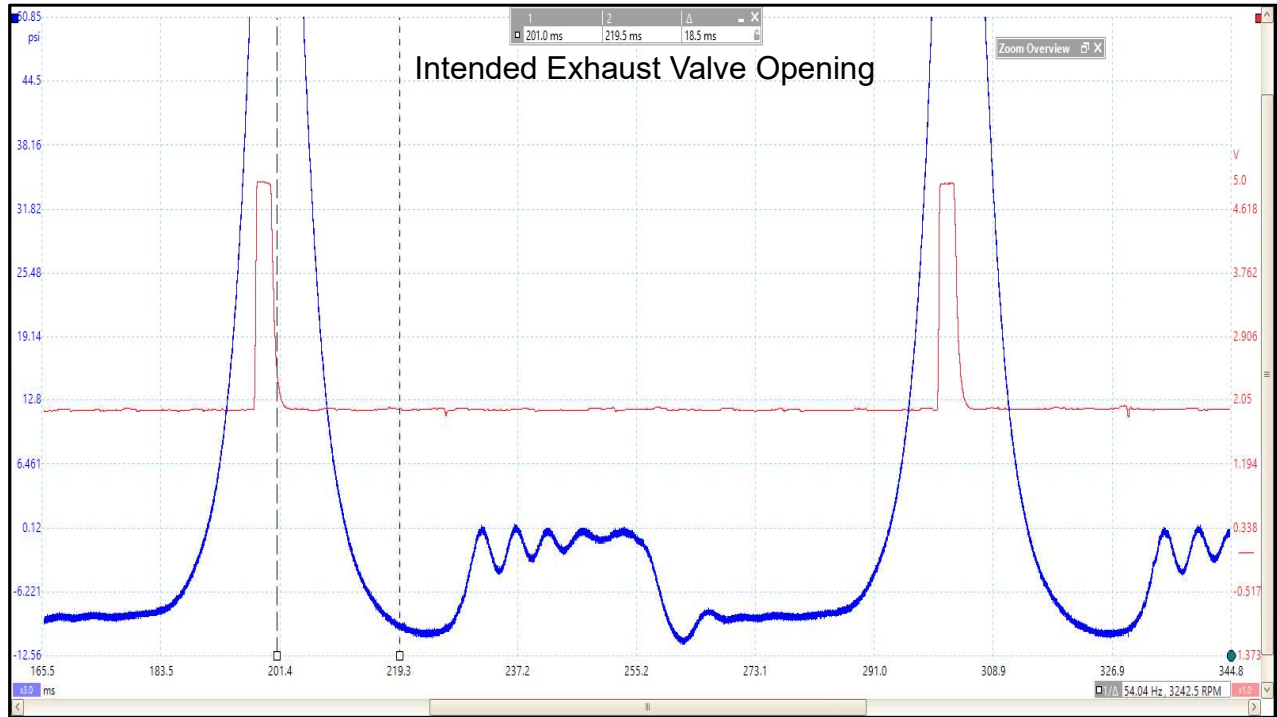
Using the calculator from the previous screen the Exhaust Valve Opening should have occurred where the cursor on the right is placed at 18.5 milliseconds away from the cursor on the left.

Exhaust Valve Openings are determined by when the pressure changes directions between the Expansion Stroke and the Exhaust Stroke. Using the example above the Exhaust Valve Opening did not occur at the intended point in time.

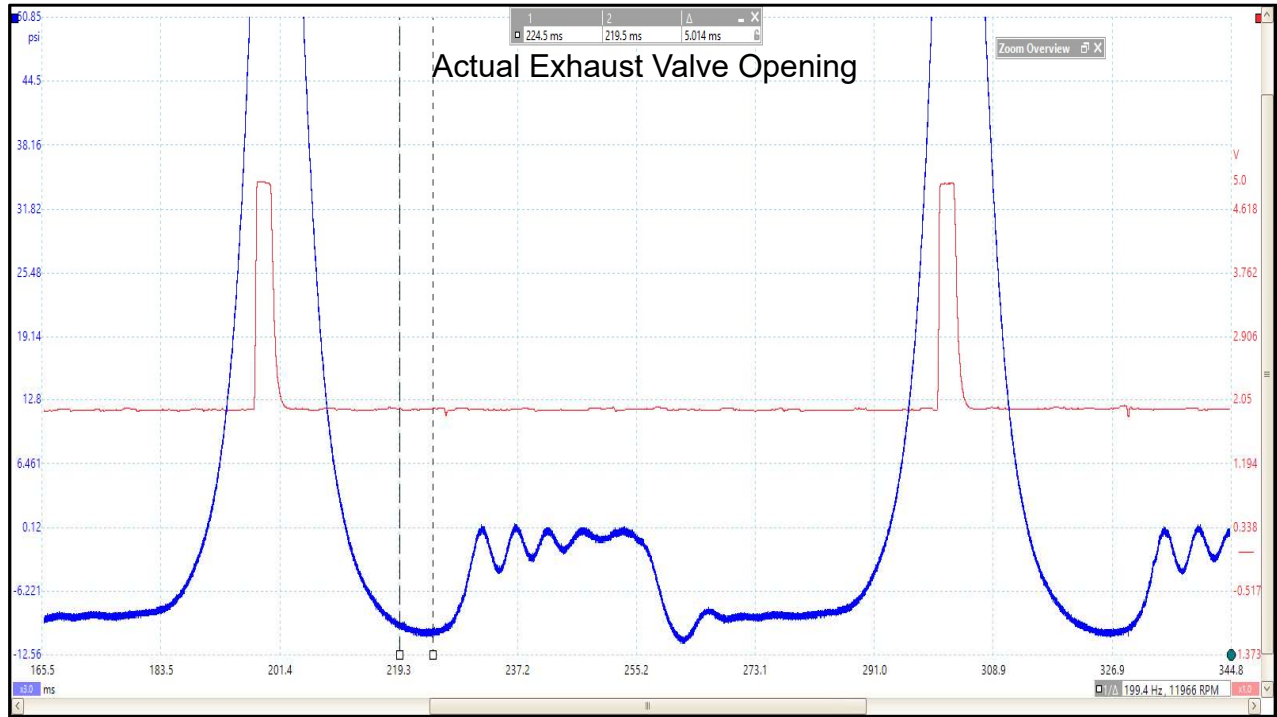
Analyzing the trace and repositioning the cursor from the left the Exhaust Valve Opening actually occurred 5 milliseconds to the right of its intended position.

This proves the Crankshaft / Camshaft Correlation is “Out of Time”, but by how many degrees?

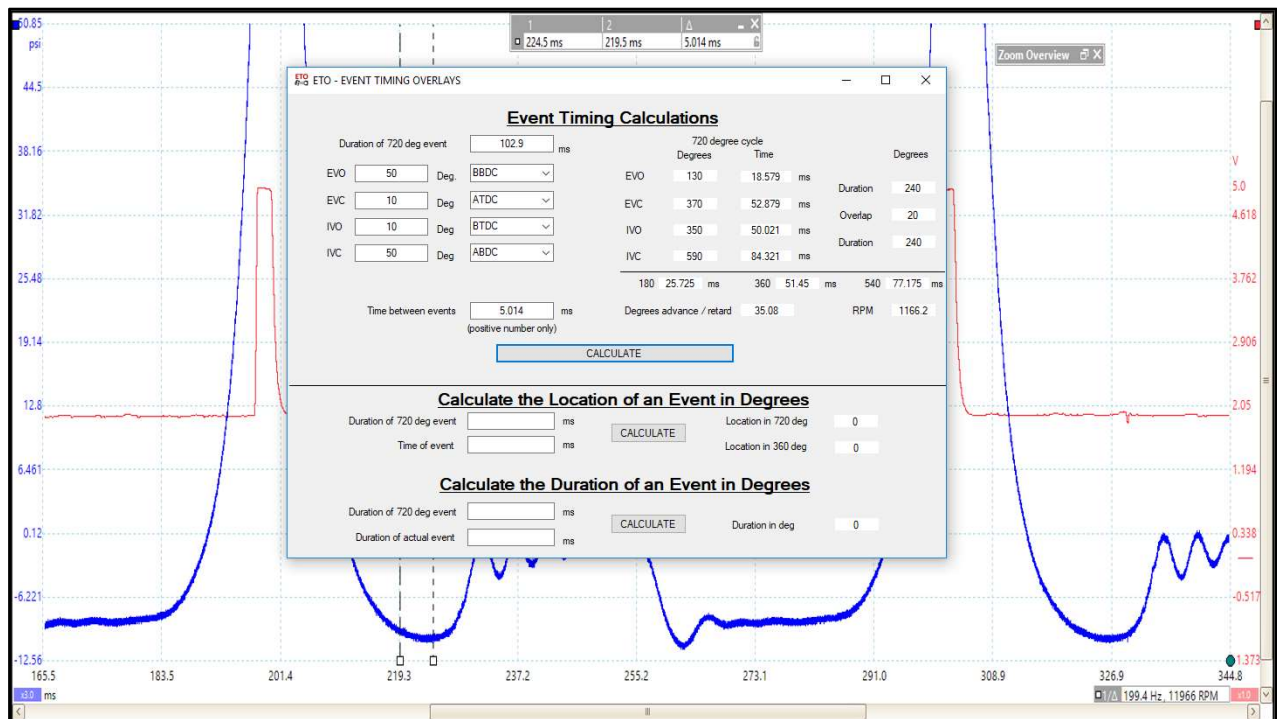
Going back to the calculator the 5 millisecond difference between the Exhaust Valve Opening's intended location versus its actual location can be re-calculated back to "Degrees of Crankshaft Rotation".

In this example the 5 milliseconds calculates to approx. 35 Degrees of Crankshaft Rotation.

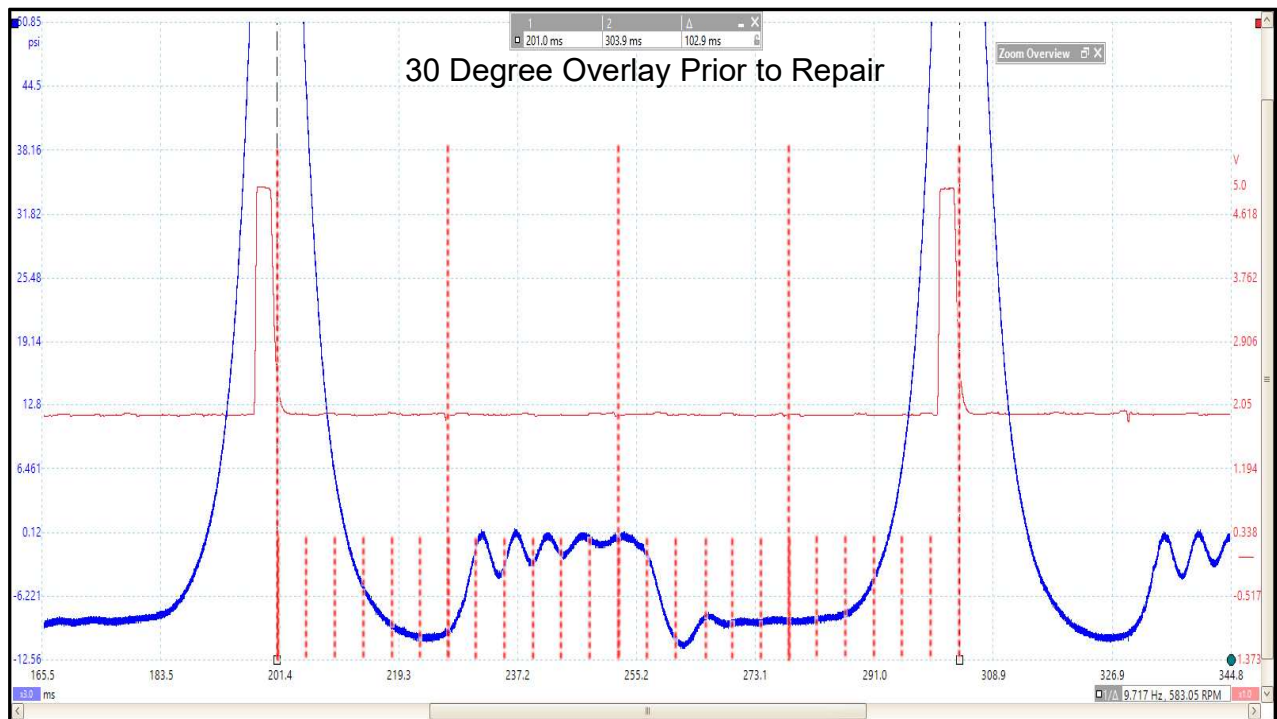
Another option for determining Exhaust Valve Opening and/or Intake Valve Closing is to use a 30 Degree Overlay.

In this example the Exhaust Valve Opening should have happened between the fourth and fifth small red lines from the left side of the waveform (approx. 45 Degrees Before Bottom Dead Center). Each of the small red lines represent 30 degrees of Crankshaft Rotation.

In actuality the Exhaust Valve Opened after the sixth small red line and slightly before the first large red line. This put the Exhaust Valve Opening at approx. 10 Degrees Before Bottom Dead Center (35 Degrees "Out of Time").

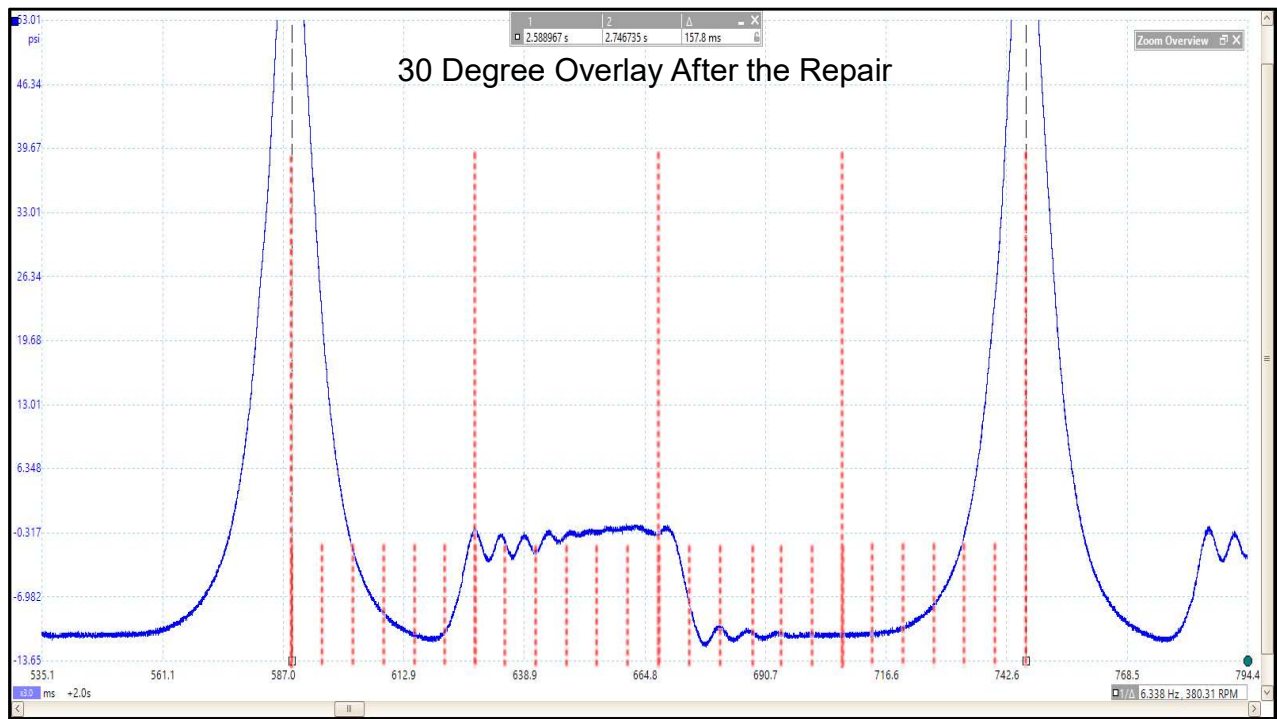
This is the In-Cylinder Waveform after a new cylinder head was installed on the engine. Note the Exhaust Valve Opening is now approx. 40 Degrees Before Bottom Dead Center. Also the point where the cylinder creates Max Vacuum is now 45 Degrees After Top Dead Center.

The entire center portion of the waveform has shifted to the left approx. 35 Degrees.

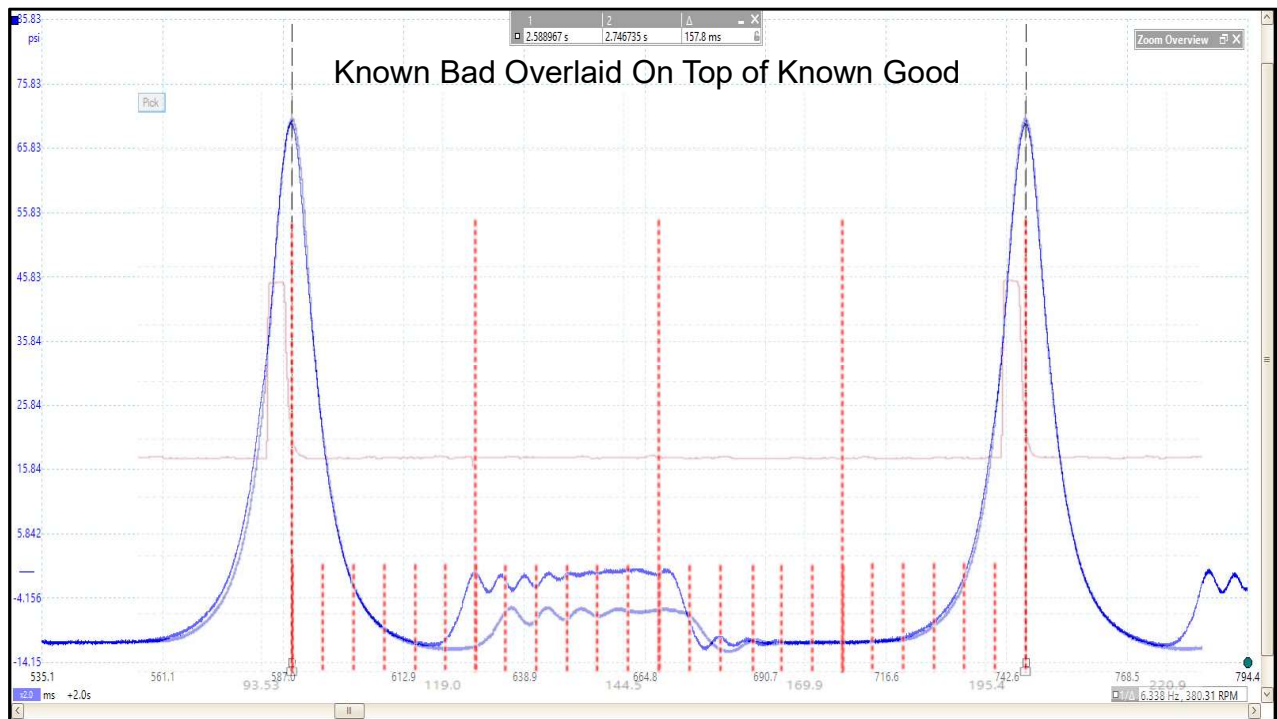
Overlaying the two In-Cylinder Pressure Transducer traces the differences / the shift is easy to see.

The after repairs compression increased to 180 psi., while the warm idle vacuum improved to 21 inches Hg.

These numbers are more in tune with what you should expect from a properly functioning Honda engine.

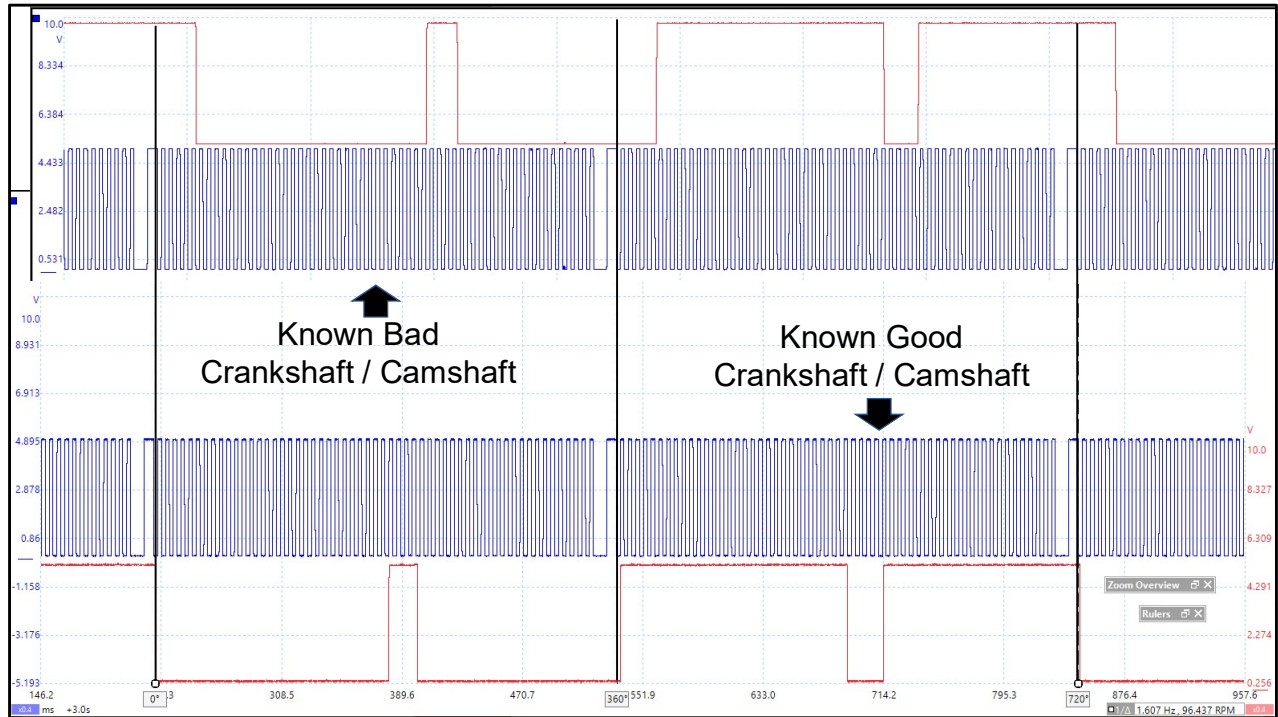
An after repairs Crankshaft / Camshaft Correlation waveform was captured. Above we inserted both the Known Bad (upper traces) and the Known Good (lower traces).

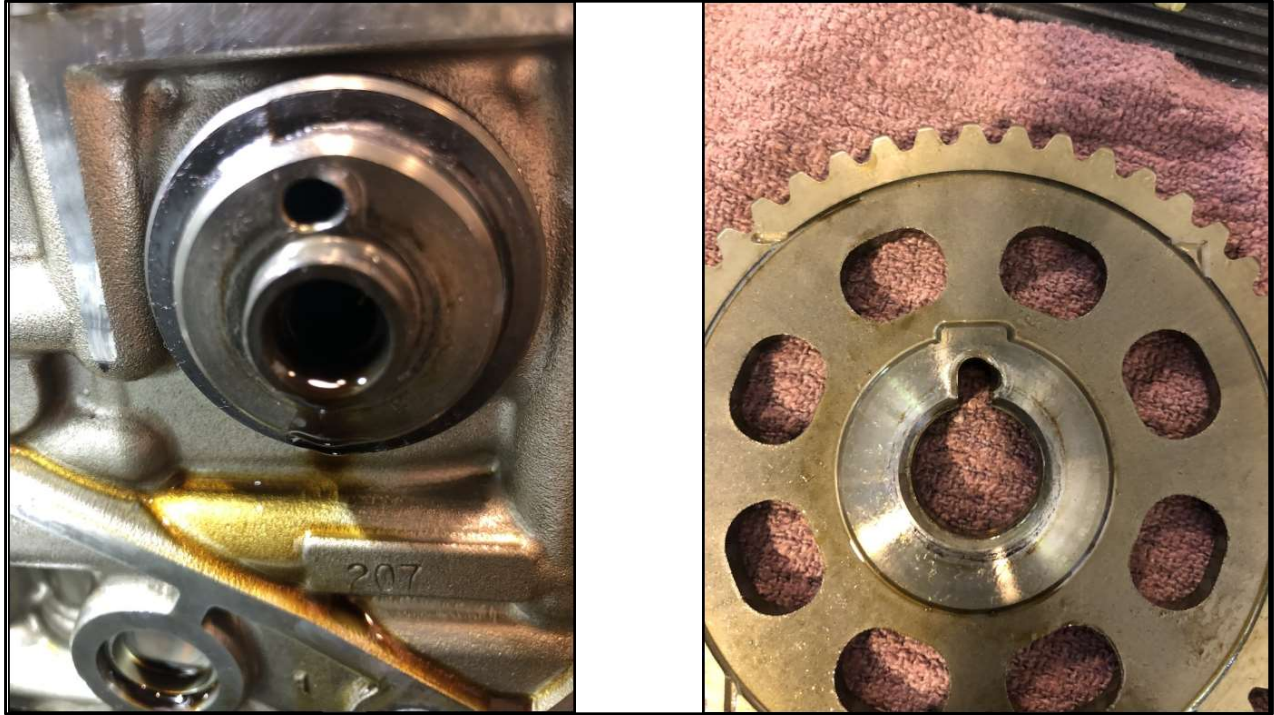
The “Root Cause” of the Crankshaft / Camshaft Correlation issue was a damaged Camshaft, Camshaft Gear and Alignment Dowel. This was most likely caused by a loose Camshaft Gear Retaining Bolt.

Other potential causes for this issue could have been a Jumped Timing Chain, a Damaged Crankshaft Gear or even a Damaged Crankshaft.
