2012 Dodge Ram Pickup 5.7 Liter Hemi V8

The vehicle came from Woodland with an illuminated MIL (Check Engine Light). The stored code was a P0308 (Cylinder 8 Misfire). The Freeze Frame Data showed the fault was occurring at 4,500 to 4,800 rpm. At idle, during testing, the vehicle didn't present itself as having a misfiring cylinder.

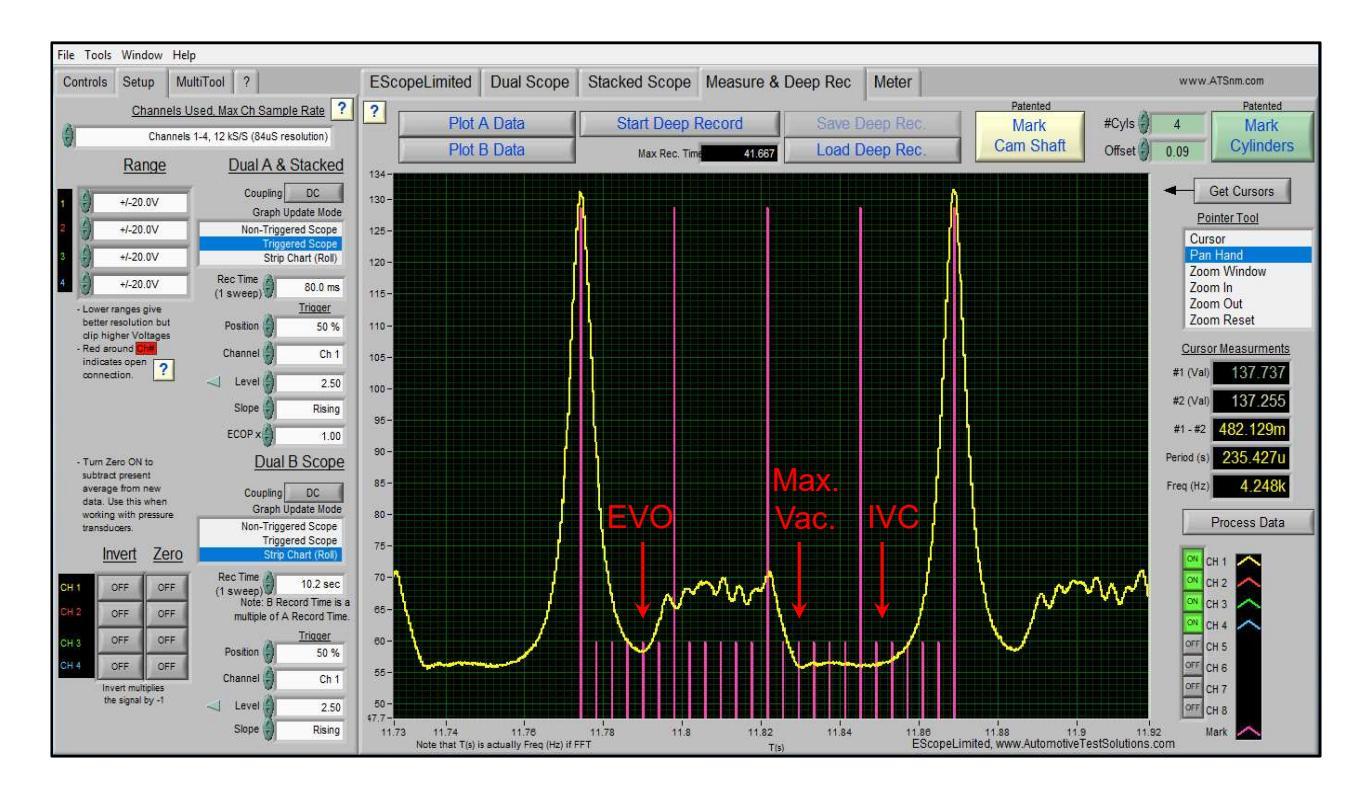
This image was taken using Automotive Test Solutions E-Scope Limited, this equipment was designed by Bernie Thompson & Neal Pederson and is available from www.aeswave.com. The screen shot above is of Cylinder #8 at Idle, looking at the image the only obvious irregularity is the time it takes for Cylinder #8 to reach Maximum Vacuum (it takes to long). Cylinder #8 doesn't reach Maximum Vacuum until approx. 60 Crankshaft Degrees after TDC Exhaust.

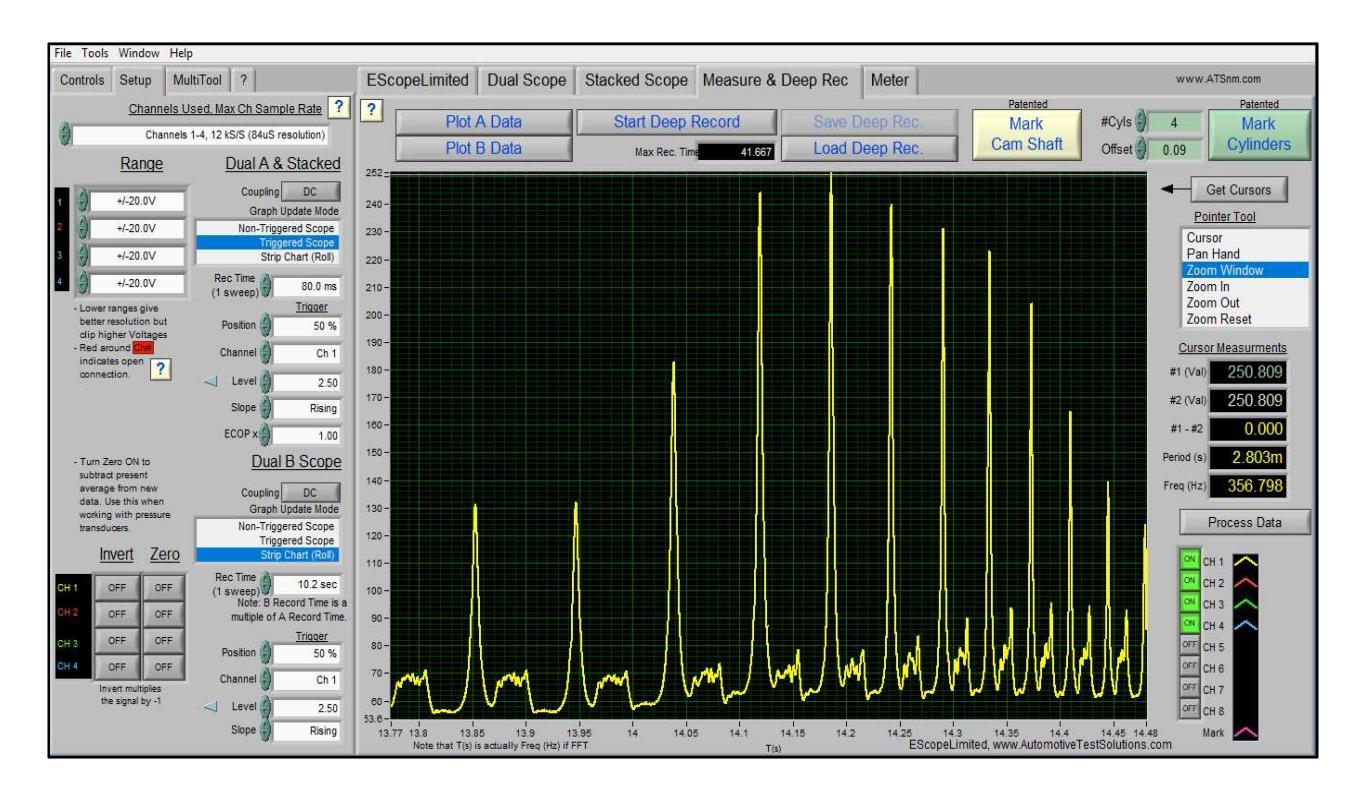
While the test equipment was still in Cylinder #8 a Snap Throttle Event was capture on the lab scope. During the Snap Throttle Event "Un-Wanted Pressure" was seen during the "Exhaust Portion" of the waveform. This "Un-Wanted Pressure" could be caused by an:

An Exhaust Valve Opening Late & Closing Early An Intake Valve Opening Late & Closing Early A Partially Plugged Catalytic Converter on Bank 2 (Cylinder # 8 is on Bank 2 of this engine)

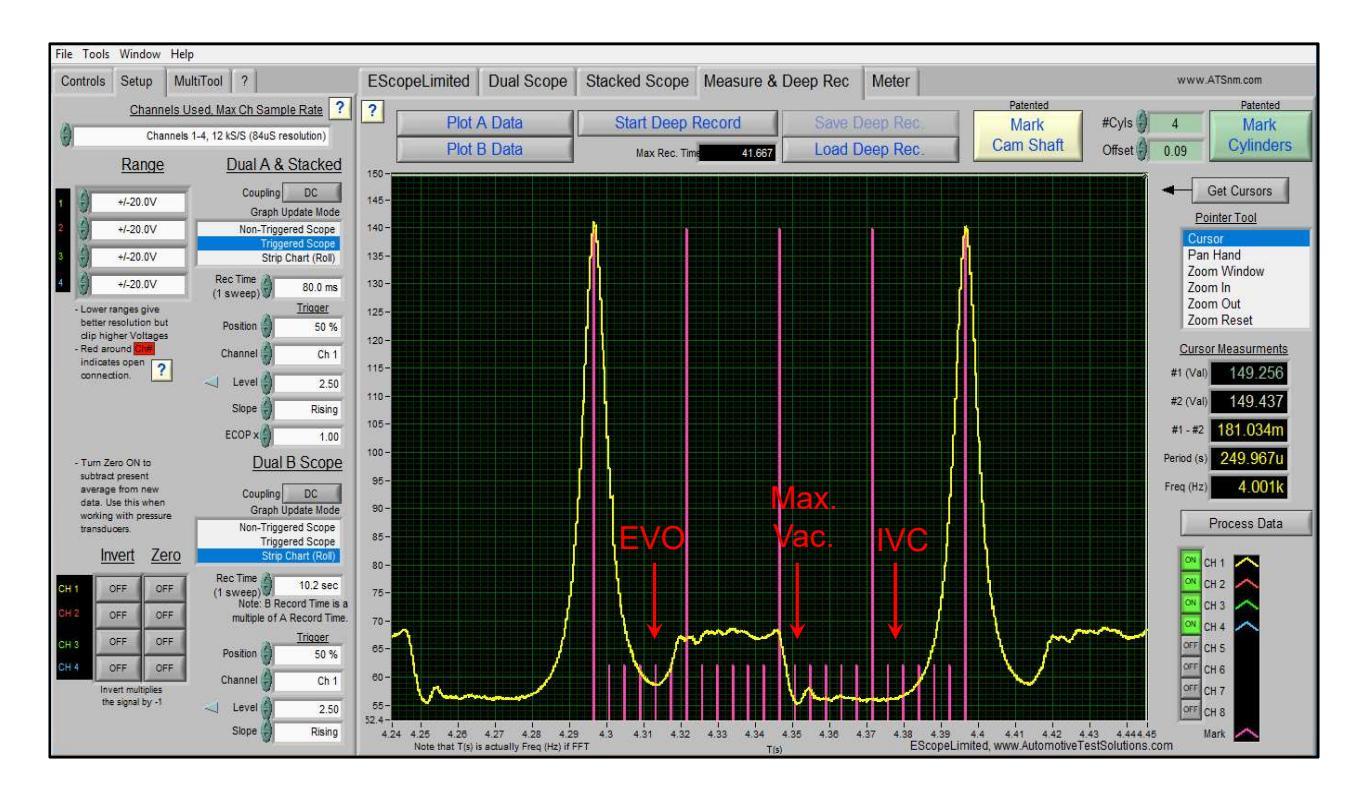
This image above was taken with the In-Cylinder Pressure Transducer equipment installed in Cylinder #3 (which is on Bank 1, the other side of the engine). Measuring the idle waveform, Cylinder #3 achieves Maximum Vacuum at 30 Crankshaft Degrees after TDC Exhaust (a full 30 Crankshaft Degrees sooner than Cylinder #8).

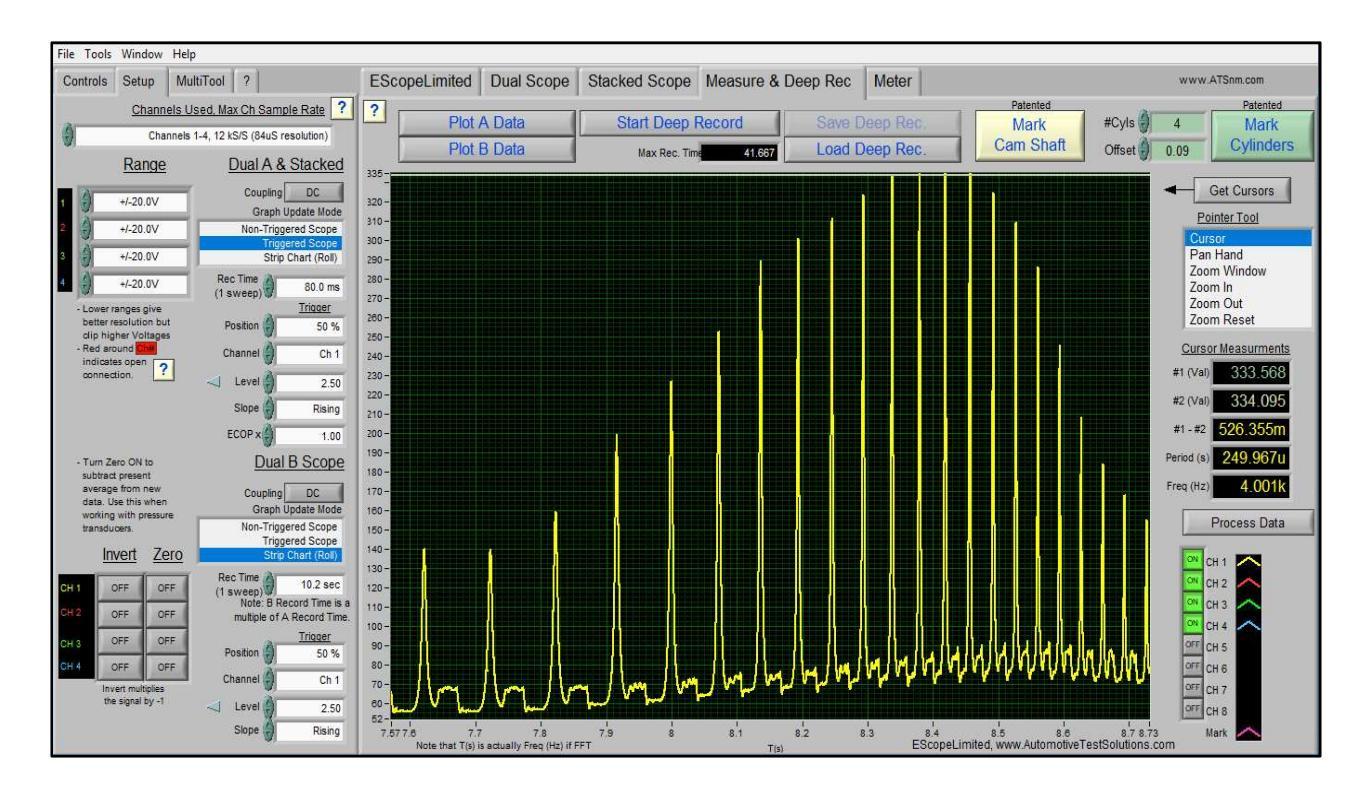
During a Snap Throttle Event on Cylinder #3 it is clear there is not the same "Un-Wanted Pressure" during the Exhaust Stroke as viewed on Cylinder #8.

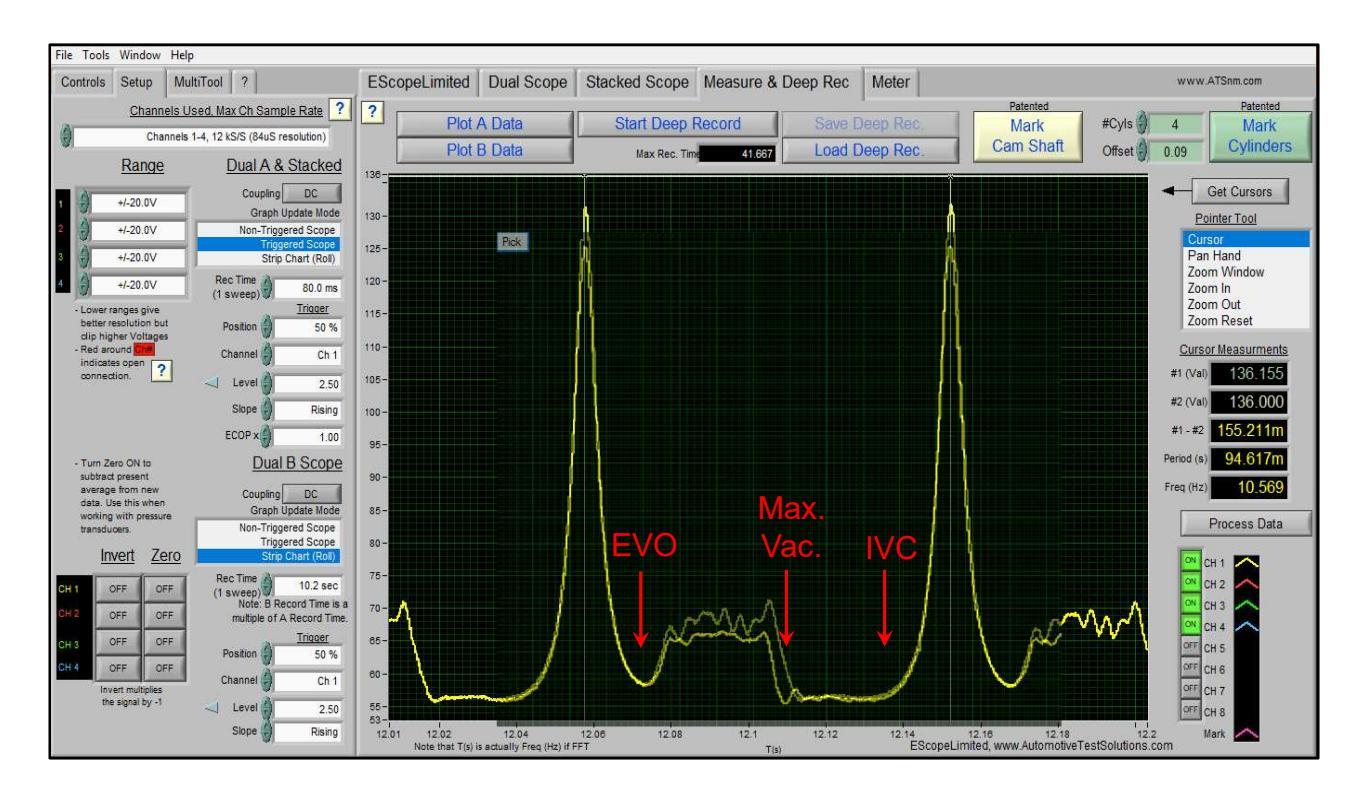
Using another feature of the Overlay Program a "Custom Overlay" can be created. Here an image of the "Known Good Cylinder" was overlaid atop of the "Known Bad Cylinder". The differences in the time in took (measured in Crankshaft Degrees) for the two cylinders (Cylinder #8 & Cylinder #3) to achieve Maximum Vacuum is clear.

1) An Exhaust Valve Opening Late & Closing Early? Using the overlaid images above, along with the two separate idle waveforms on pages 4 & 6, the Exhaust Valve Openings are identical measuring approx. 60 Crankshaft Degrees Before BDC.

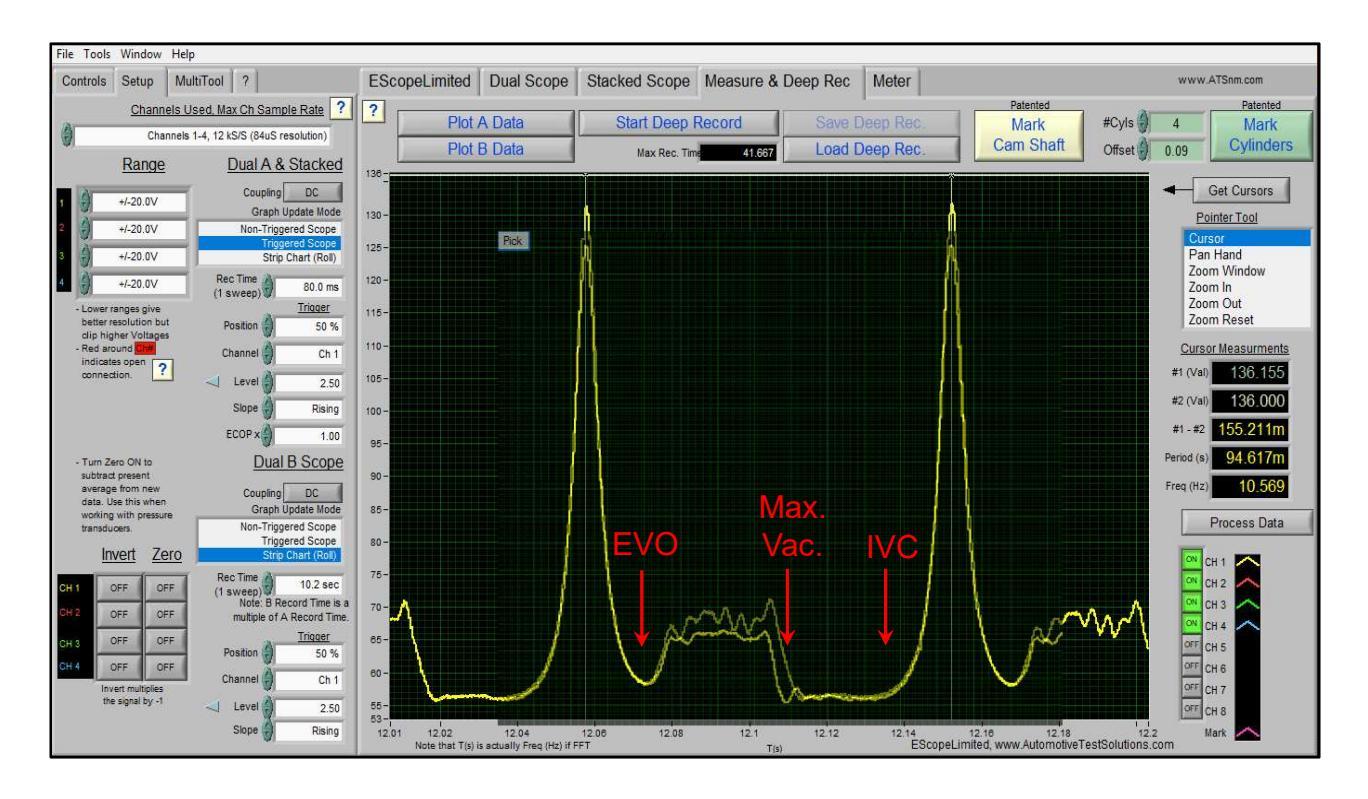
2) An Intake Valve Opening Late and Closing Early? Using the overlaid images above, along with the two separate idle waveforms on pages 4 & 6, the point at which each waveform reaches Maximum Vacuum is different by approx. 30 Crankshaft Degrees. If the Intake Valve Opens Late, the cylinder looses "Valve Overlap" so the possibility to see a "Rise in Pressure" at the end of the Exhaust Stroke (during Snap Throttle Testing) make sense. Also when comparing the results of the testing to the customer's complaint along with the Freeze Frame Data the diagnosis makes sense. If at high engine speeds, the Intake Valve isn't opening properly the cylinder won't get enough Air / Fuel Volume for combustion.

3) Partially Plugged Catalytic Converter? If Bank 2's Catalytic Converter was partially plugged "Yes" it would cause "Un-Wanted Pressure to Rise" during the Exhaust Stroke but that un-wanted pressure wouldn't alter the "Time" it took for cylinder to achieve Maximum Vacuum and more than likely the vehicle would have more than a single cylinder misfire.

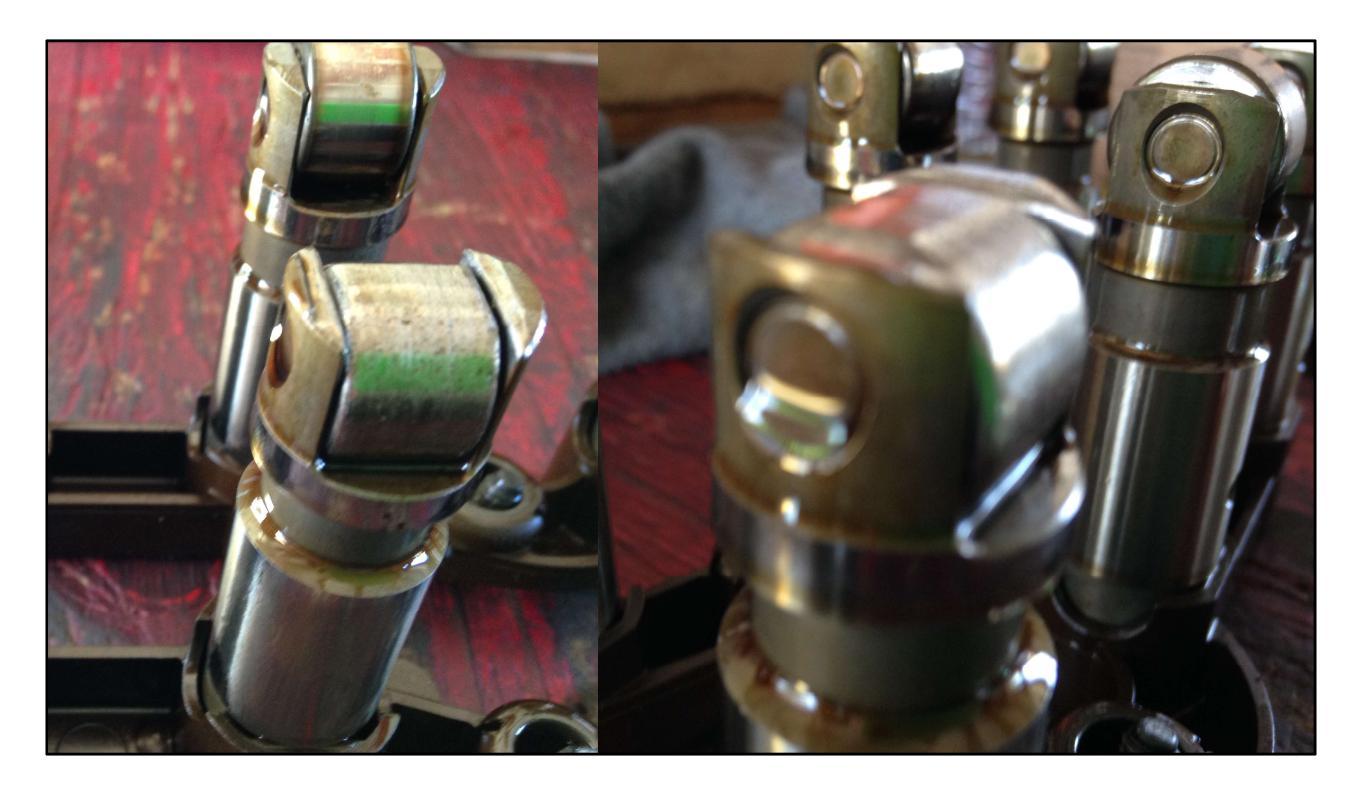
Maximum Vacuum differences between cylinders can only be altered by altering Intake Valve Timing, because this engine has a centrally located camshaft (which is used for both banks) camshaft timing can't be the root cause. This engine has a single cylinder misfire so the root cause must be confined to Cylinder #8, a Collapsed Intake Lifter, a Bent Intake Valve Push Rod or a Flat Intake Camshaft Lobe for cylinder #8 are all possibilities.

The two images above are of the Roller Lifter Assemblies used in the 5.7 Liter Hemi V8. The roller for Cylinder #8's Intake Valve has seized and actual ground itself away (the upper half of the roller is missing). This missing portion of the roller and subsequent damage to the camshaft journal (not pictured) was the reason for the Late Intake Valve Opening as seen using the In-Cylinder Pressure Transducer.

These Lifter Assemblies are located underneath the cylinder heads so in order to replace these units, the engine must be disassembled. Using In-Cylinder Pressure Transducer Testing this entire diagnosis was accomplished by removing two spark plugs and the total time was approximately 1 hour.
