2012 Dodge Ram Pickup 5.7 Liter Hemi V8

The vehicle came from Woodland with an illuminated MIL (Check Engine Light). The stored code was a P0308 (Cylinder 8 Misfire). The Freeze Frame Data showed the fault was occurring at 4,500 to 4,800 rpm. At idle, during testing, the vehicle didn't present itself as having a misfiring cylinder.

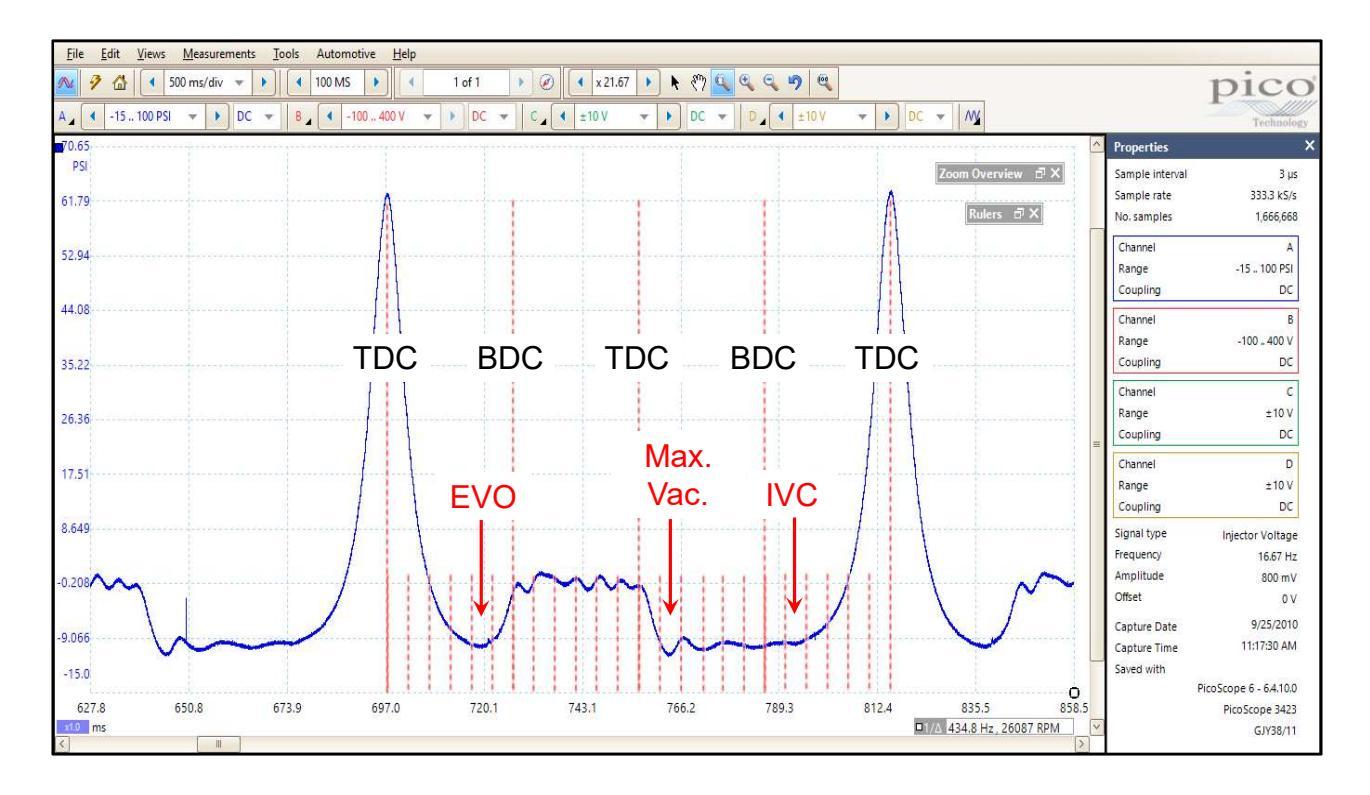
Another popular overlay is the 30 Degree Overlay, this overlay breaks up each 180 degree area into 30 degree smaller increments. It is used to accurately measure Valve Opening and Closing Points in relationship to Crankshaft / Piston Position.

In the image above:

The Exhaust Valve Opens at approx. 45 Crankshaft Degrees Before Bottom Dead Center (EVO)

Maximum Vacuum happens at approx. 45 Crankshaft Degrees After Top Dead Center (Max Vac.)

The Intake Valve Closes at approx. 45 Crankshaft Degrees After Bottom Dead Center (IVC)
